Tree-Ring Dates of Vigas in Casa Blanca, Jemez Springs, New Mexico

Thomas W. Swetnam
Jemez Mountains Tree-Ring Lab
Laboratory of Tree-Ring Research
University of Arizona
June 17, 2018

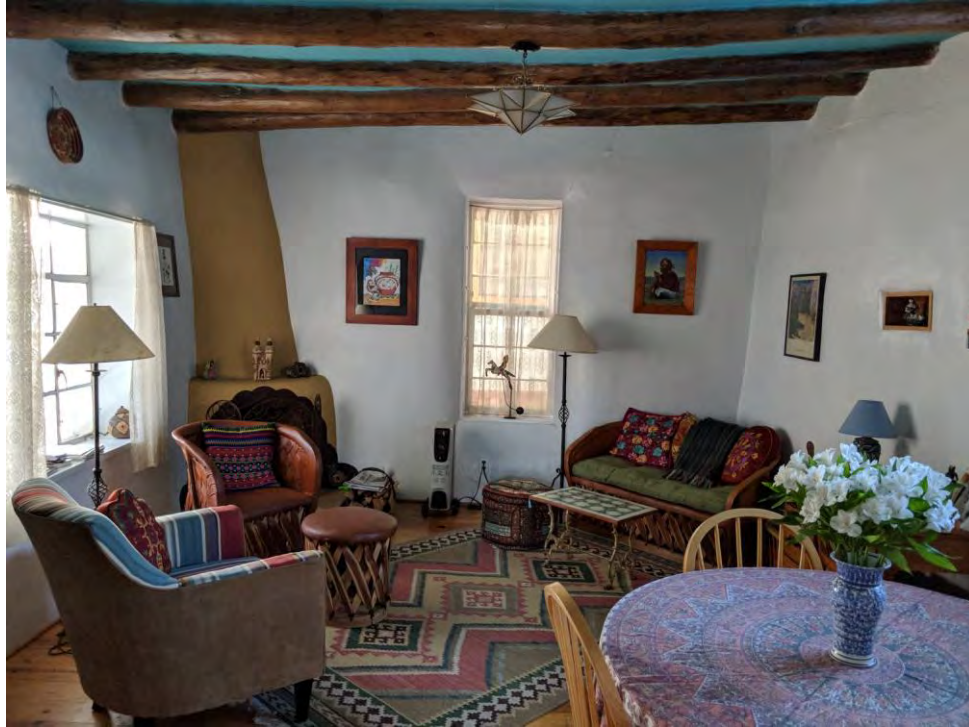
Viga #1 was cored right above the basket on the wall above the left window.

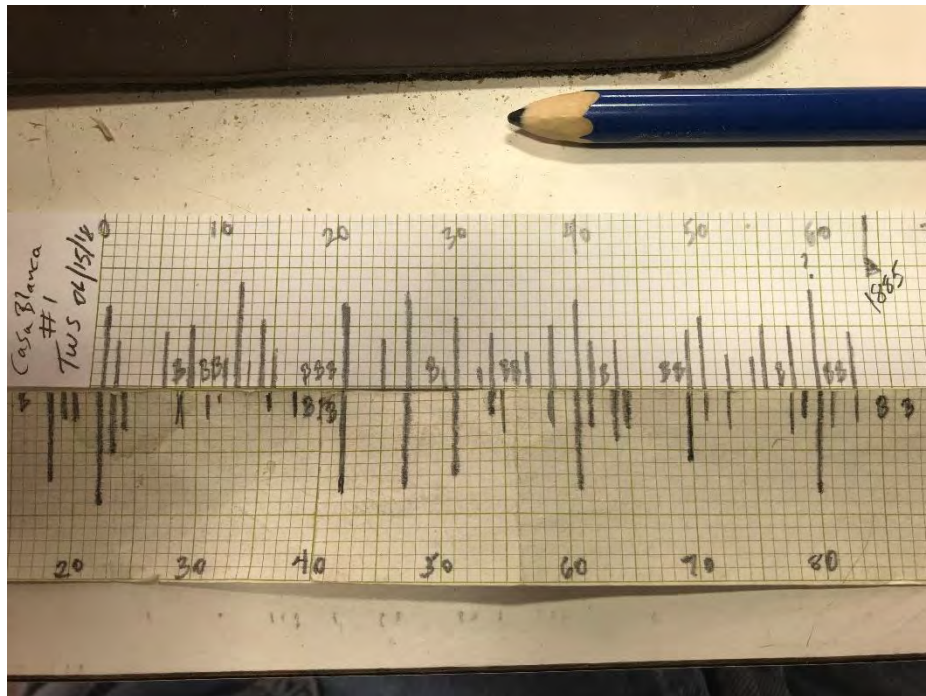
Skeleton plot from specimen # 1 (top) compared with the master composite plot bottom. Good correspondence of the smallest rings (long pencil lines) and most big rings (B). Anomalous small ring in 1833 may be an injury.

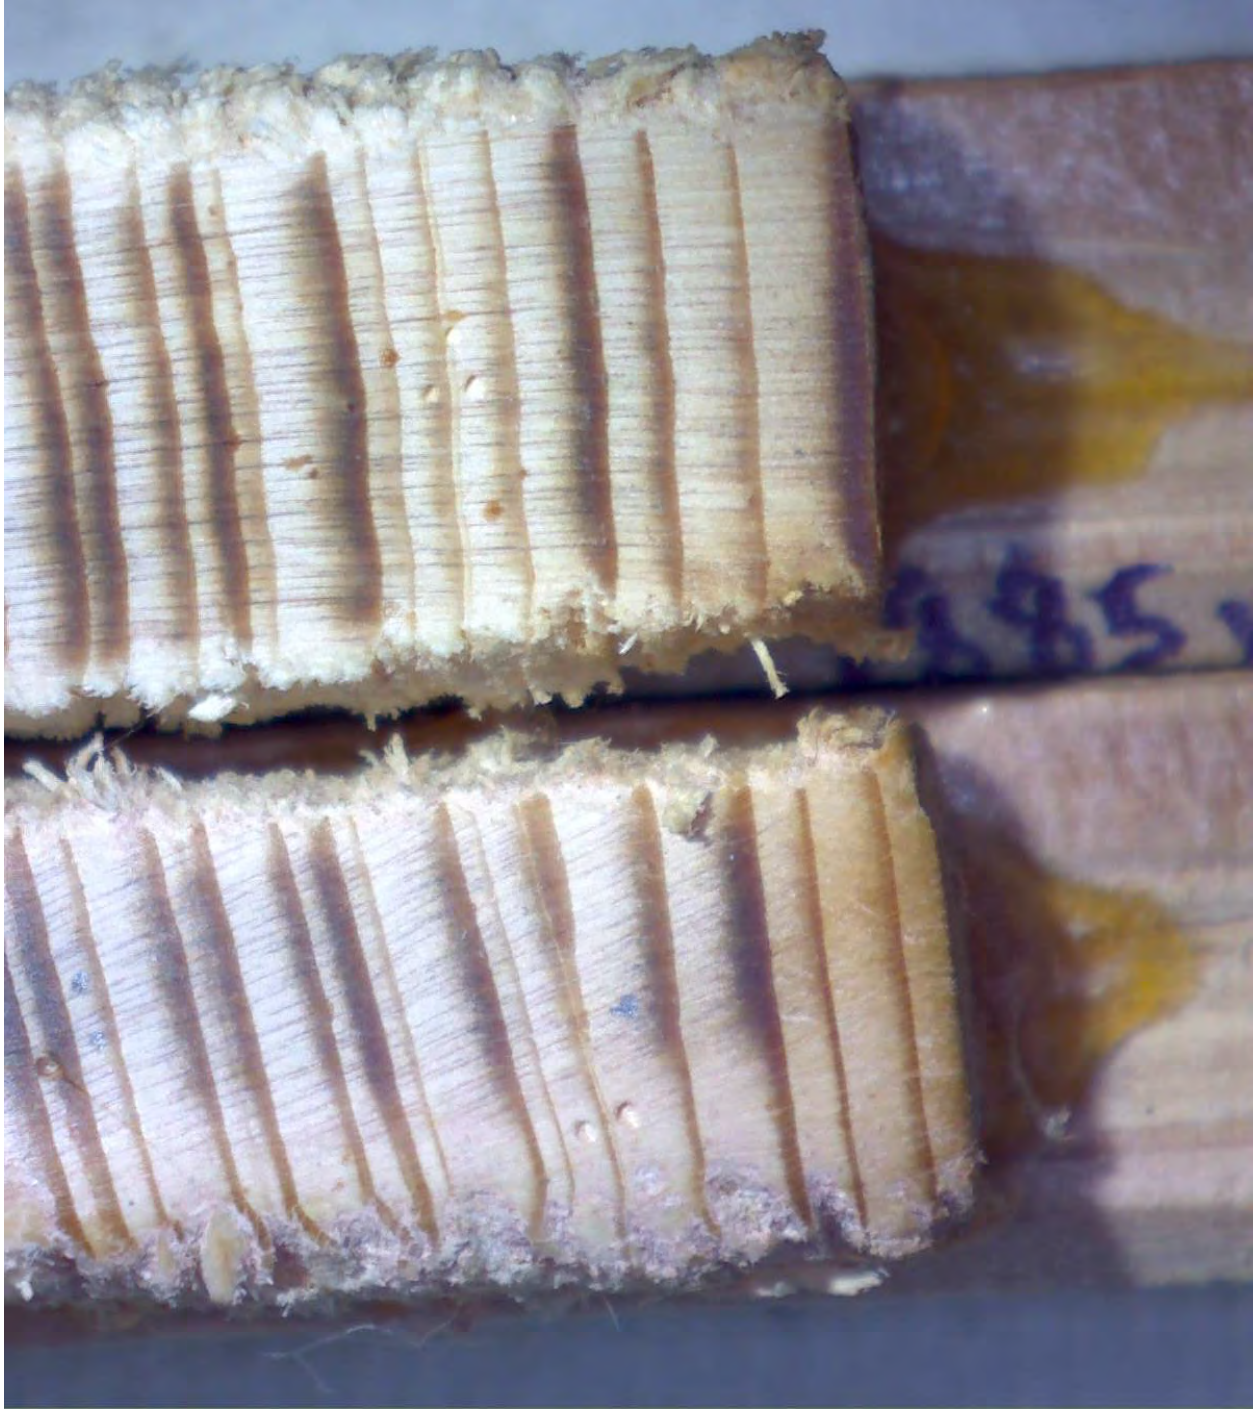
Outermost rings on specimens #3 (top) and #1 (bottom). Note very small ring in 1880, marked with two pin prick holes on either side of the ring. Note very faint lighter colored cells just after the latewood of 1885 in #3. At first, I thought these were earlywood cells from 1886. On closer examination, however, I think they are bark cells. Hence, #3 has a cutting date of 1885.

Specimen #	Inner Date	Outer Date	Notes
1	1821 pith	1885v	- A few latewood cells visible in 1885; good crossdating
2	1846 far from pith	1877vv	-short core, broken off inside & out
3	1865 far from pith	1885b	-Short core, broken off inside only; probable bark on outside
4	1813 pith	1886++	-Core broken in 2 places after 1860, ring counted only after that
5	1851 near pith	1888v	-Crossdates well visually with master & with #1

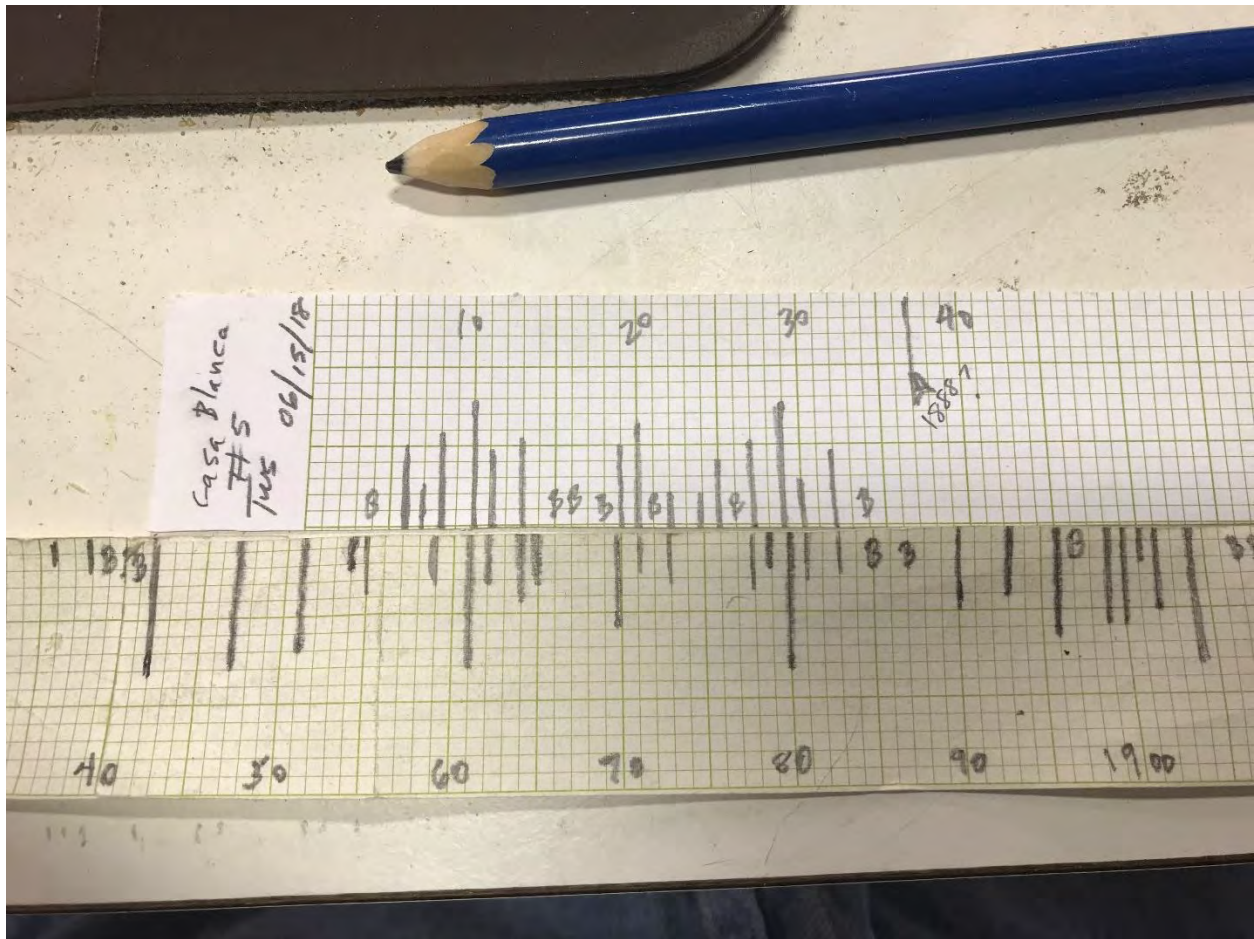
Crossdating of specimen #5 from the kitchen (upper plot) with the Jemez Mountains composite (bottom). This is a good match, but a short sequence. Visual comparison of the ring characteristics in this specimen with longer dated sequences in specimens #1 and #4 is convincing though.

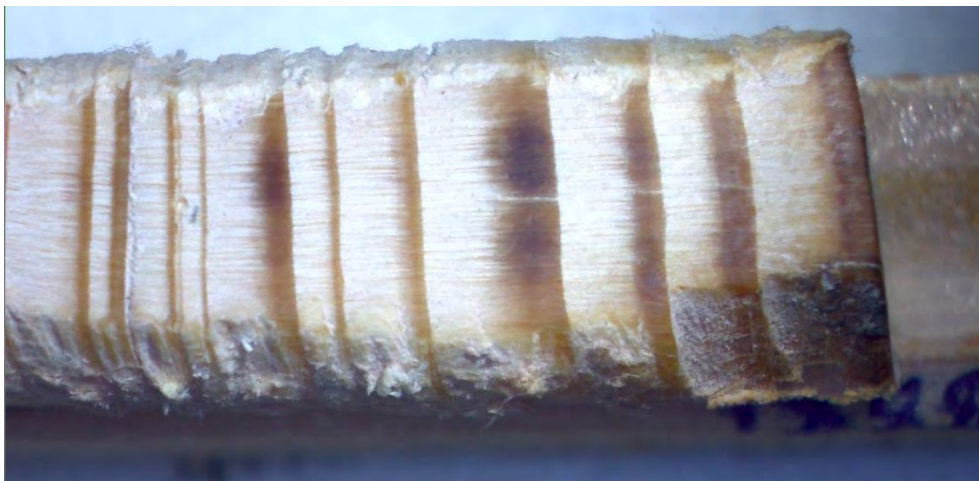
Specimen #5. Note the very small ring in 1880, with a single pinprick hole in it.

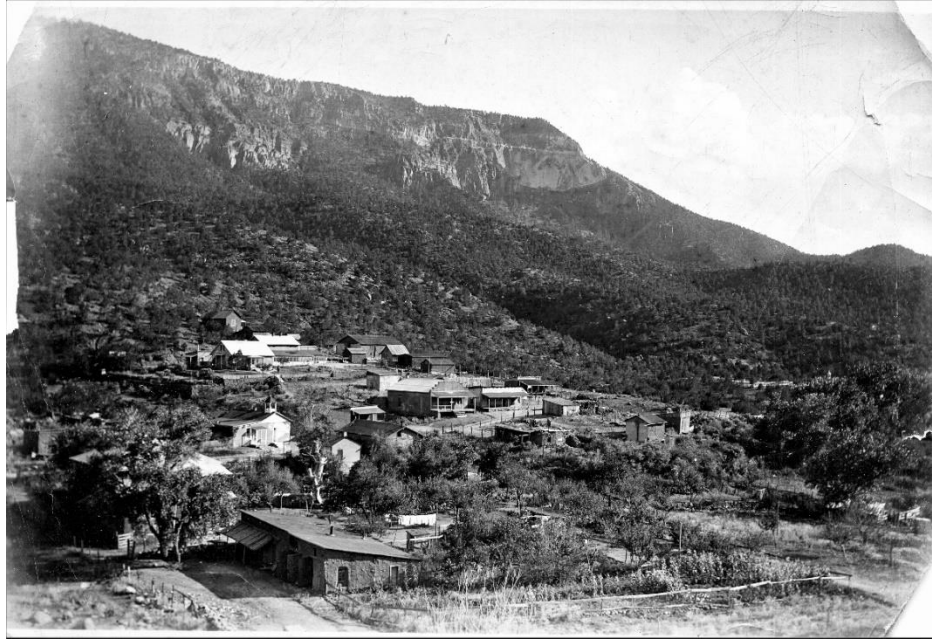
This is a view of the Jemez Springs Village (Jemez Hot Springs, as it was known then) probably taken between circa 1900 and 1910. The large Abouselman house is visible in the lower left behind trees, and I think that was constructed around 1900. Other landmark buildings that are still visible in this photograph and still in existence include the Presbyterian Church, the Miller house and compound, and the mercantile later known as the “Laughing Lizard”. The Casa Blanca living room area is probably the buildings at right center.

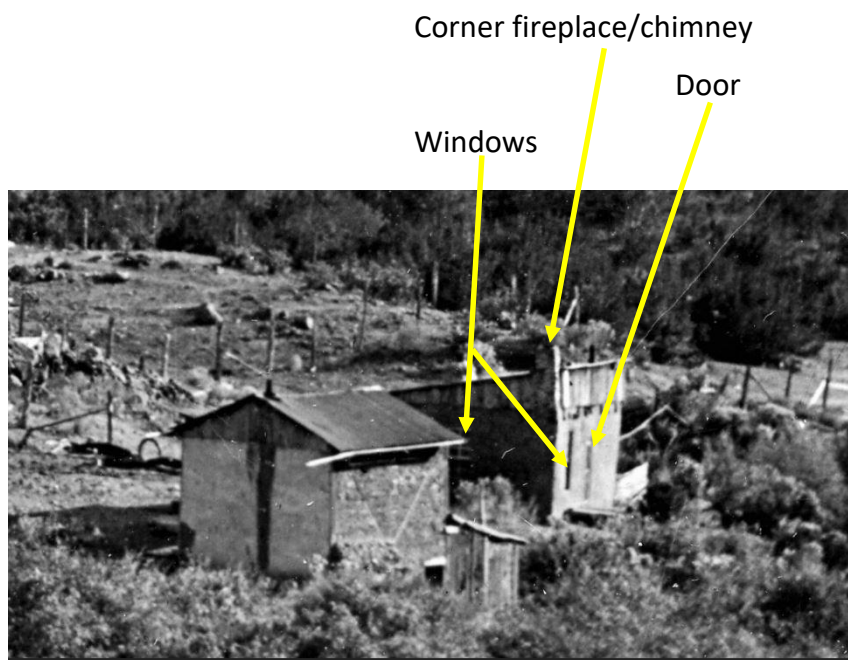
Zoomed in view from the larger photo showing the likely Casa Blanca living room.

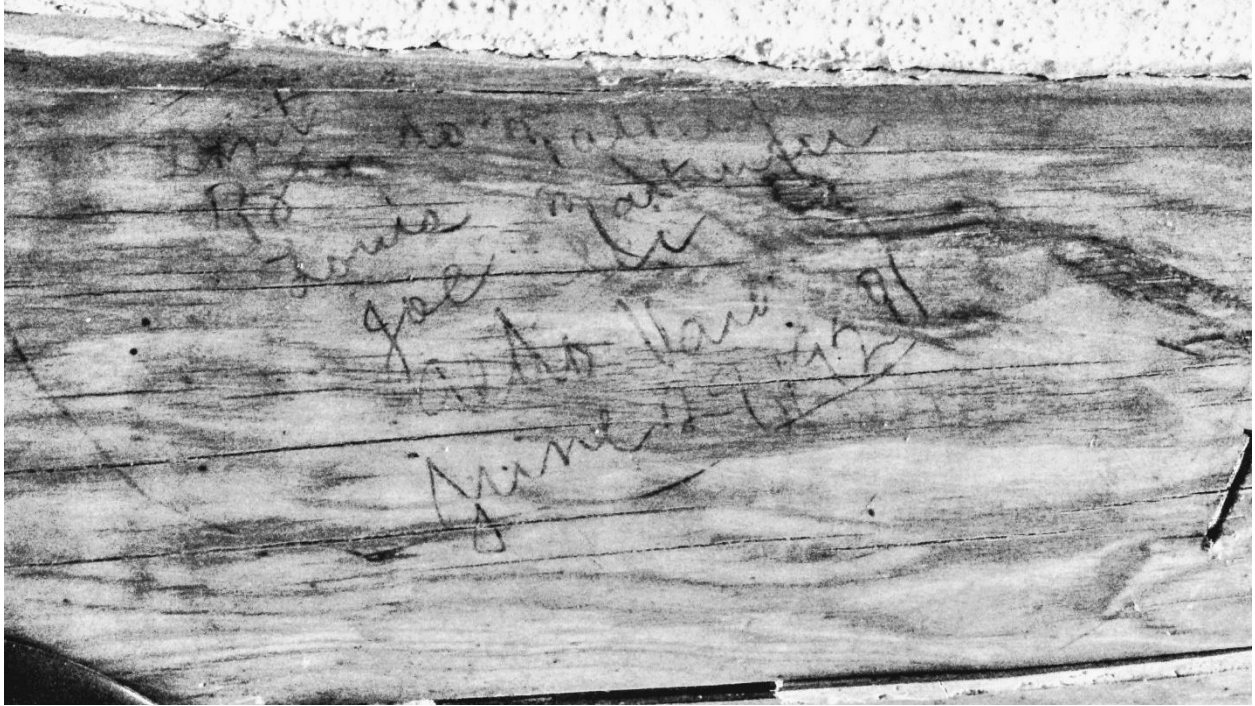
Pencil markings on center viga in living room. These appear to be names, and a date. Perhaps as follows:

Dante no(?) Martinelli (or Martinez? But I don't see a "z")
Rosa(?)
Louis Martinelli
Joe ler(?)
Aedo(?) Varo
June 29, 1929
