Tree-Ring Dates from the Hot Sulphur Bath House, Jemez Springs, New Mexico

Thomas W. Swetnam
Laboratory of Tree-Ring Research
University of Arizona
Tucson, AZ 85721

November 17, 2015

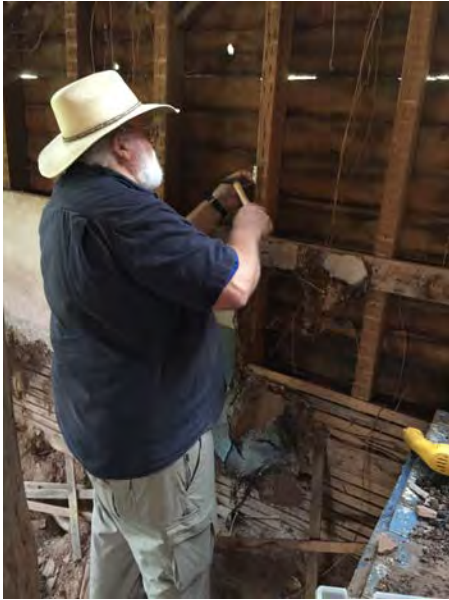
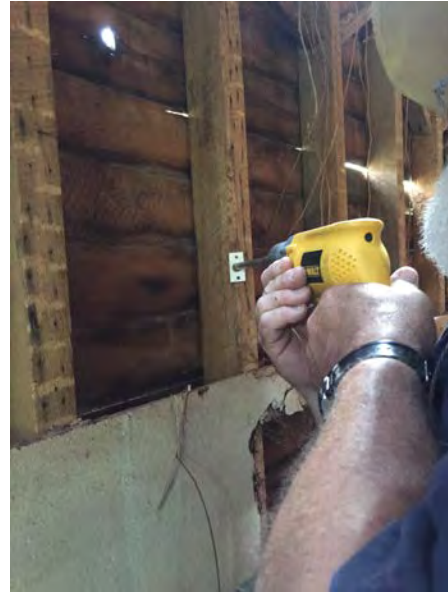
A drill guide was used to stabilize the drill bit as a core was extracted from the waney edge showing on a wall stud. The sample shown above was HSB2 from the northern wall of the large room.

Two of the core samples from the wall studs (HSB 2 & 3) were crossdated, but the core from the ceiling stud (HSB 4) could not be confidently crossdated. The latter specimen had too few rings and too little ring-width variations to match it with the composite Jemez chronology. The two dated core samples both have outermost ring dates of 1895. The 1895 ring is incomplete, with only a few latewood cells in one case at the outside. Again, this indicates the tree was harvested in the summer time. The two dated cores have very similar ring patterns overall, and it seems possible these wall studs came from the same tree.

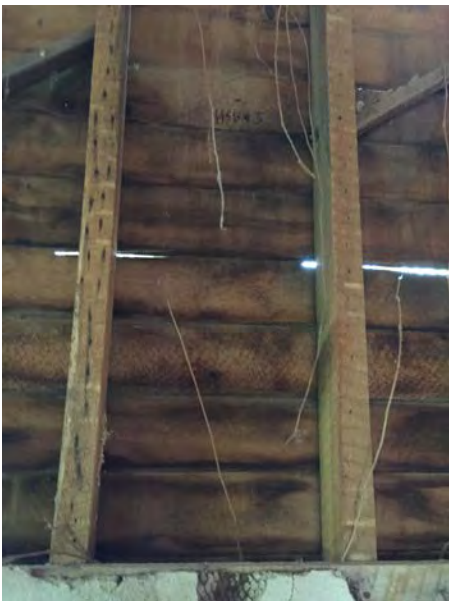
The location of one of the wall cross-supports was in the center of the photo on the left, and other examples of wall cross-supports are visible in the upper left and upper right corners of that photo. The photo on the right shows the cut end of the board (HSB8, upper center) taken from the false front on the small room addition on the east side of the building.

One of the boards sampled (HSB1), which came from the NE corner of the large room, crossdated very well with the composite Jemez chronology, and it also had an outermost tree-ring date of 1891. The other board (HSB8), which came from the false front of the small room at the front of the building, could not be confidently dated because it had too few rings.

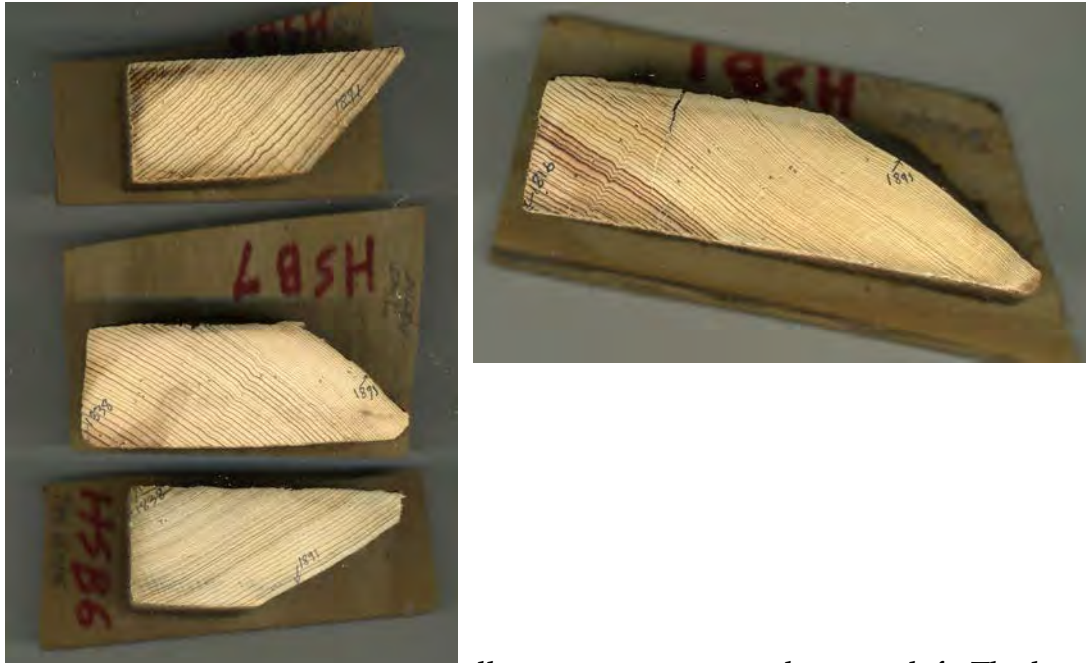
Examples of the mounted and sanded wall cross-supports are shown at left. The board HSB1 is at upper right. Two of the core samples (HSB 2 & 3) are shown at lower right.
