Tree-Ring Dates of Boards and Beams from Block-Bergmann Structures, Jemez Springs, New Mexico

Thomas W. Swetnam
Jemez Mountains Tree-Ring Lab
Laboratory of Tree-Ring Research
University of Arizona
September 16, 2022

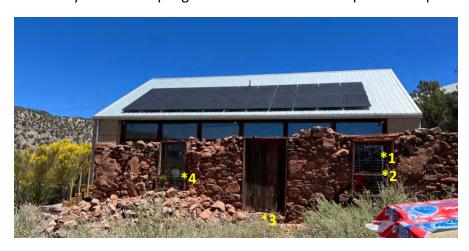
In June, 2022 I obtained 7 core samples from old boards and beams from buildings currently owned by Bill & Shelli Bergmann in Jemez Springs. The samples are all 3/8-inch diameter cores obtained with an electric drill. Core samples labeled #1, and #2, were from boards of the window casement on the east side of the stone wall of the current patio on the south side of the Bergmann house (see photo below). This wall appears to be the original external south wall of what was probably the barn building associated with the Block Hotel. I will provide a brief history of the Block family and their Hotel in Jemez Springs at the end of this report. Core sample #3 was from the lower door sill in the center of the same wall as described above. Core sample #4 was from the western window casement in the same wall. That core jammed in the bit and came out in many pieces; it was not examined. All cores were taken from parts of the boards that appeared to be waney edges. All sampled surfaces were highly weathered, so even if they were waney edges it is likely that one to several rings may have eroded away before sampling. Cores #1 to #4 were all ponderosa pine.

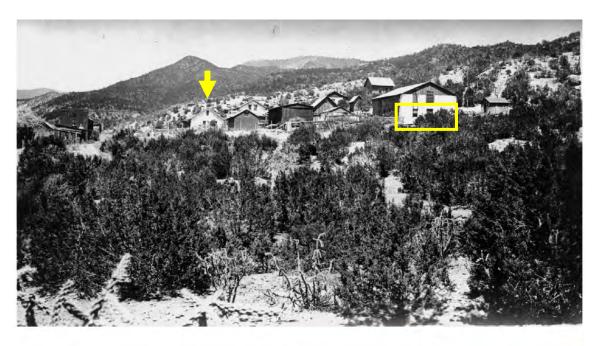
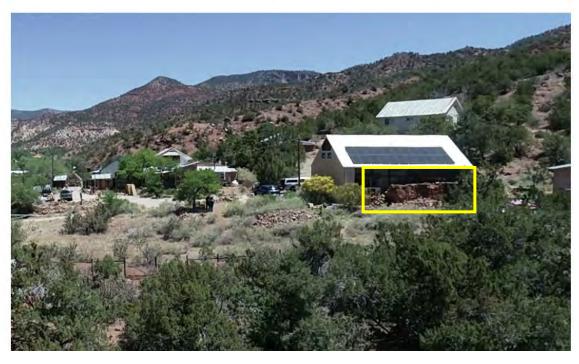
The photo below from about 1910-20, and modern view shows the Block Hotel and the Block residence (yellow arrow), and related buildings. I have an old postcard with a similar view that identifies the Block residence as the one indicated, and the building at far-left edge in this photo as the post office. Mr. Block was postmaster in the 1880s and 90s. Part of the barn structure with the south wall, windows and doorway still exist today as the patio wall of the Bergmann house (yellow box). Note that the current Bergmann house has a roof peak oriented west-east, while the old building's roof peak was north-south. It is possible that the west wall of the modern Bergmann house includes part of the original west wall of the barn.
