# **Tree-Ring Dating of the Adams House**

## **Jemez Springs, New Mexico**

*A Report by Thomas W. Swetnam*

Jemez Mountains Tree-Ring Lab  
Laboratory of Tree-Ring Research, University of Arizona  
April 27, 2026

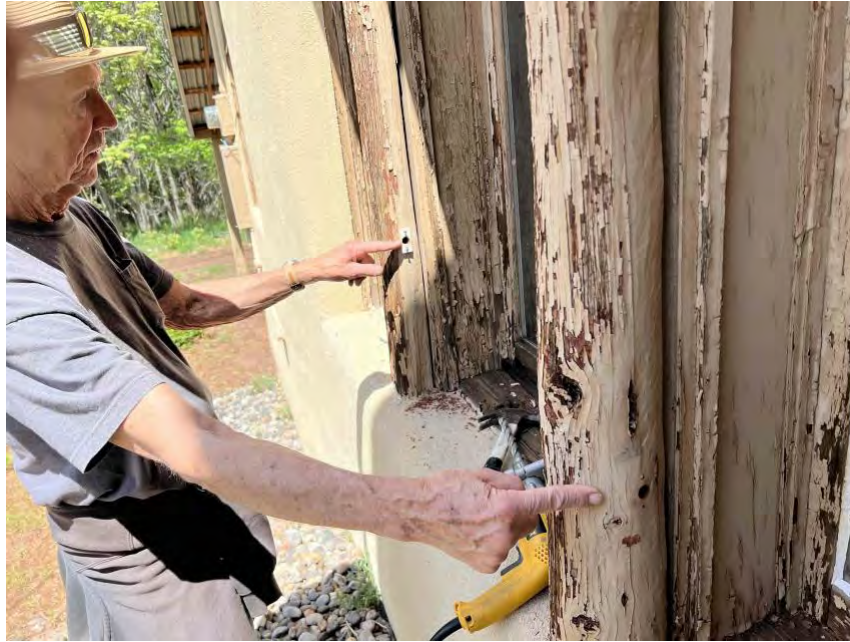
*Fig. 1. Roger Sweet pointing out the two juniper window-header timbers (Adams 1 and Adams 2) in an exterior, south-facing wall. Each was cored for tree-ring analysis.*

**Adams 1** (core, juniper). Exterior window-header timber. The outer rings are very narrow and not reliably crossdated; however, a tentative crossdate of the inner ~50 rings places the outermost surviving ring, by ring-counting toward the outside, in the early 1890s. Because the outer rings are so narrow and the crossdating is tentative, this

**Adams 2** (core, juniper). Second exterior window-header timber. The ring series consists of very small rings throughout, with probable false rings; no crossdate could be established, and this sample is therefore undated.

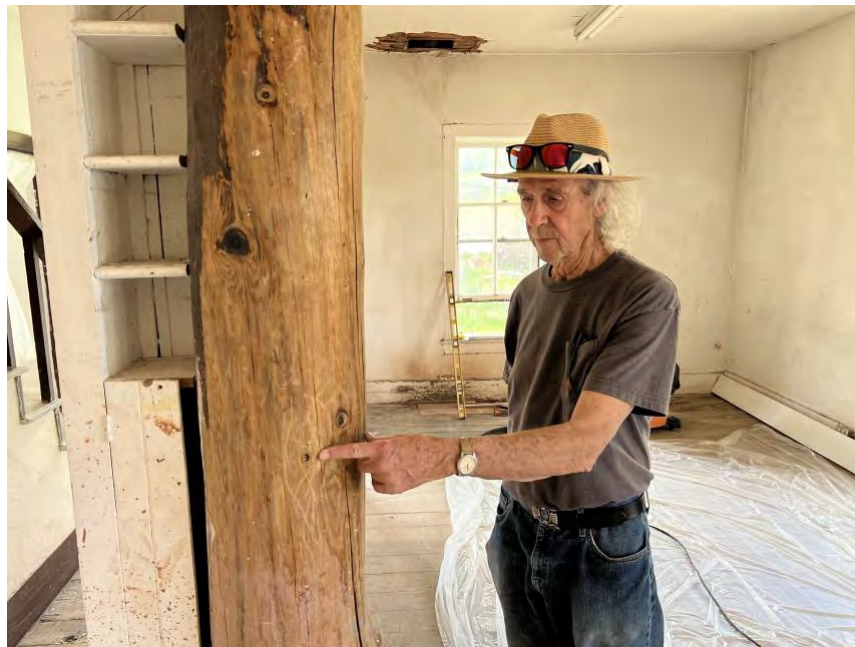
*Fig. 2. The large ponderosa pine vertical support post in the living room (Adams 3). The post is set against the north wall and carries part of the upstairs floor load. Its obviously improvised position (notably, it is not structurally integrated with the masonry wall behind it) suggests that it was added during a later remodel; the tree-ring date of 1922 or 1923 confirms this.*

**Adams 3** (core, ponderosa pine). A large vertical support post in the living room, against the north wall (Fig. 2). The ring series is fast-growing and complacent, with fewer than 60 rings. It crossdates with the Jemez master chronology and yields an outer cutting date of 1922 or 1923.

The second episode is represented by four ponderosa pine samples (Adams 3–6), all yielding cutting dates of 1922 or 1923. Two of these samples are vigas in the northeast addition, and two are the vertical interior support posts in the living room. It is striking that both the addition and the interior reinforcement appear to date to the same felling year (or years), strongly implying a single coordinated remodel of the house ca. 1922–1923. This remodel plausibly included opening the upstairs bedroom wall into a single room, as Roger Sweet has observed, which would have transferred additional floor load

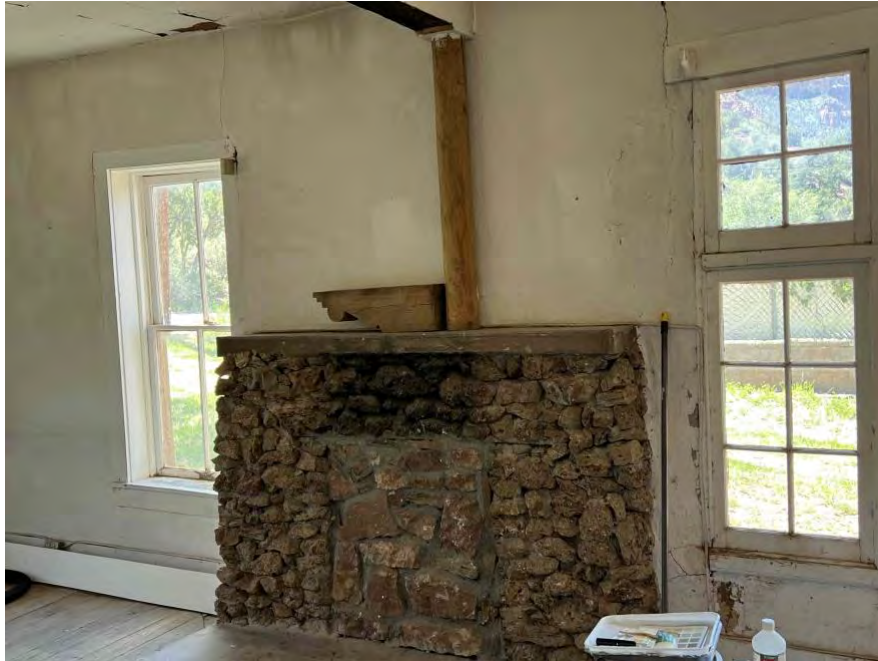
*Fig. 3. The living-room fireplace, showing the smaller vertical ponderosa pine post (Adams 4) rising from the mantle toward the ceiling. The pole is somewhat oddly positioned, again suggesting post-hoc structural reinforcement rather than a feature of the original build.*

**Adams 4** (core, ponderosa pine). Smaller vertical post above the fireplace mantel (Fig. 3). The ring series cross-dates fairly well. Outer date 1922.

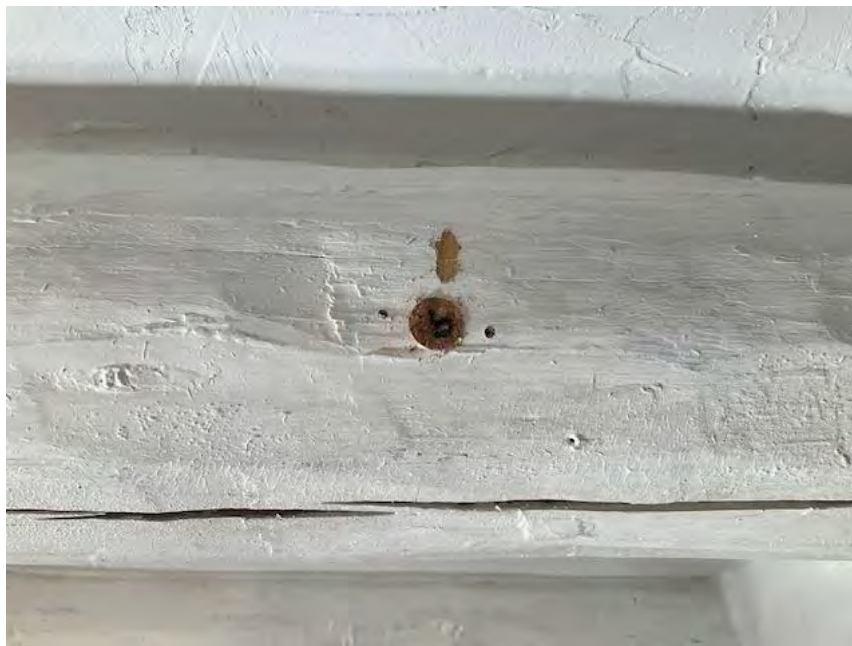
*Fig. 4. Increment core hole in one of the ponderosa pine vigas in the northeast addition (Adams 5 or Adams 6). Both vigas yield outer cutting dates of 1922 or 1923, which, like the two interior support posts, suggest the same felling season, implying that the living-room reinforcement and the northeast addition were completed as a single remodeling campaign.*

**Adams 5 and Adams 6** (cores, ponderosa pine). Vigas in the northeast-side addition. Both samples crossdate in their inner portions; near the outer end, each contains some missing or false rings, and the outer (cutting) dates are therefore obtained by careful ring counting from the last confidently crossdated ring toward the waney edge. The outer dates are probably 1922 or 1923.

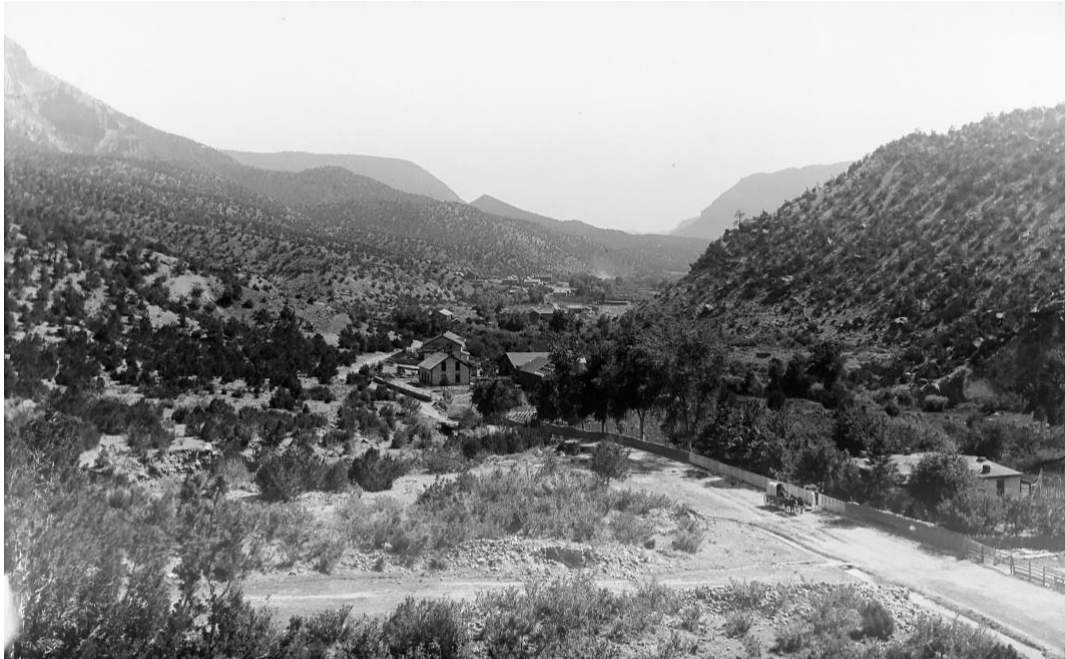
*Fig. 5. NMSU Library archival photograph, probably from the late 1890s to ca. 1910, looking south down San Diego Canyon toward the center of Jemez Springs. The Shields House is the one-story adobe at the lower-right, with two horses and a wagon in front of its picket-fence gate. The two-story Adams House (then most likely the Fenton House) is visible in the distance at center-left, just west of a low rock wall along the road. The large barn to the right (west) of the house has its east-facing roof blown off; a second, larger barn with an east-west roof pitch is visible behind it and was owned by A.J. Otero. The Forest Ranger station was built in about 1928-29, so it is not present in this photo.*

The Shields House is visible in the foreground of the NMSU archival photograph shown below (Fig. 5), with two horses and a wagon in front of a picket-fence gate. The later Adams House appears in the distance at right, just west of the north-south low rock wall along the road. The large barn on the other side of the east-west low rock wall, with an east-west roofline, was owned at the time of this photo by A.J. Otero. He had purchased that property, along with extensive orchards extending down the valley, from Rudolph Haberland in 1896. Haberland had earlier bought the property from the Varos (or Baros) family in 1882 (documents in Ancestry.com). Otero and Fenton had a court dispute in 1896 over the use of the old Haberland barn, and after that, in the same year, Fenton built the other barn on his property with a north-south roofline orientation.

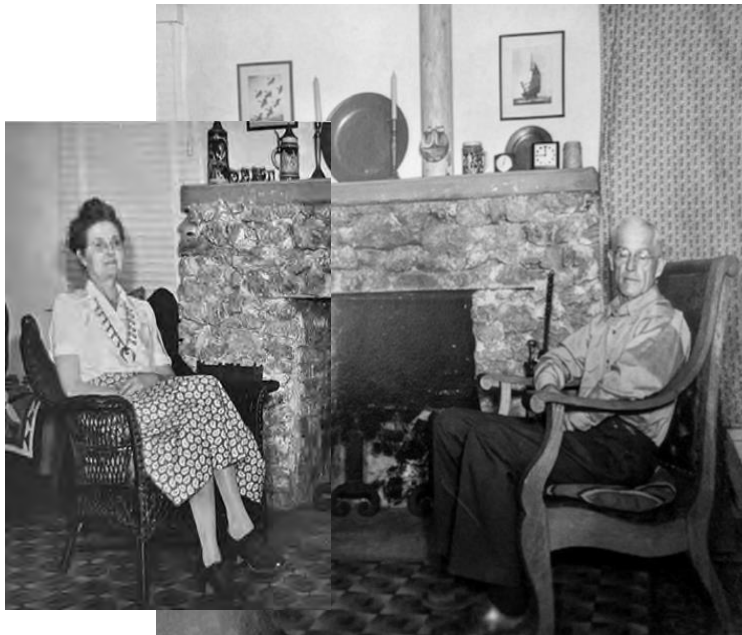
*Fig.7. Composite of two Adams family photos showing Helen and John seated in front of the fireplace sometime in the 1940s or 50s, with the vertical post above the mantel visible.*

Family tradition records that John Amos and Helen Belle Adams purchased the house around 1946 and used it as their retirement home. Helen was the daughter of the Reverend Dr. John Milton Shields, so her move into this house across the arroyo from her childhood home is a notable continuity in the neighborhood. A family snapshot of the interior (Fig. 9) shows John and Helen Adams seated in front of the stone fireplace; the smaller vertical ponderosa pine post (Adams 4), whose tree-ring date is 1922, is already in place above the mantle in the photograph, confirming that the post was an existing feature when the Adams family acquired the house and was not installed by them.

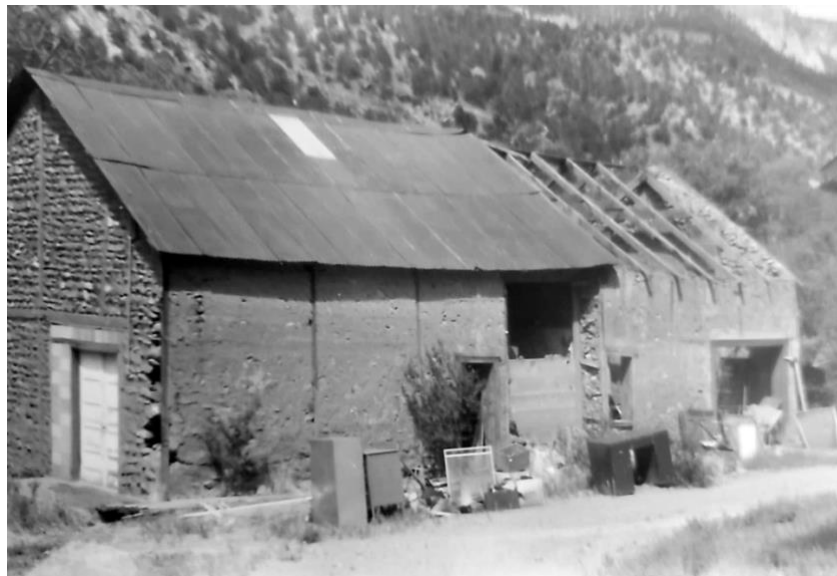
*Fig. 9. Photograph of the barn immediately behind the Adams House, probably mid-twentieth century, supplied by Paul Adams, Jr. The barn was demolished soon after they traded the property; the Douglas-fir timber recovered from its footprint (Barn 1) was cross-sectioned and crossdated, but the surviving outer ring of 1864 is weathered and decidedly older than the true cutting date.*

**Barn 1** (cross-section, Douglas-fir). Collected from a thicket of trees-of-heaven behind the house, next to some old concrete steps that are the surviving footprint of a barn. Good crossdating. The outermost ring is 1864. Because this timber was milled on three sides and the outside was weathered, only some of the original sapwood is preserved and none of the bark, so the actual cutting date is well after 1864 — probably years to a couple of decades later. The inner end of the series extends into the early 1800s.

Photographs taken by family members in the mid-twentieth century show a substantial adobe-walled barn with a sheet-metal roof immediately behind the Adams House (Fig. 10). This was undoubtedly the barn that Rev. E.M. Fenton built after his dispute with A.J. Otero in 1896. According to Paul Adams, Jr., the barn was demolished shortly after the Adams family's exchange with the Servants of the Paraclete: the roof was first removed and the adobe walls were then smashed inward. The large Douglas-fir timber that we recovered from that footprint was almost certainly an original barn timber. The outermost surviving rings are in the early to mid-1800s, so the timber was old enough to be consistent with a late-1890s construction date (i.e., the Fenton barn episode of 1896, recorded in a newspaper account), but the dating cannot be pinned any more tightly than "later than 1864" from the sample in hand.

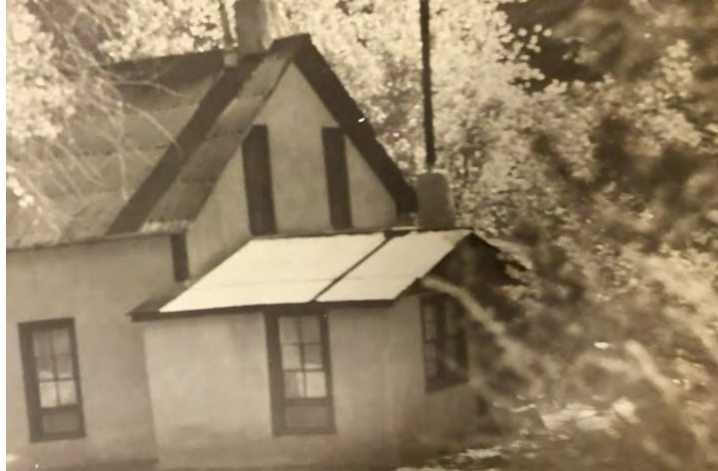
*Fig. 10. The Adams House in a ca. 1950s family photograph. The steep gable, the two second-story windows, and the shed-roofed porch are still present today. By the time of this photograph, the 1922–1923 reinforcements and northeast addition had long been in place.*

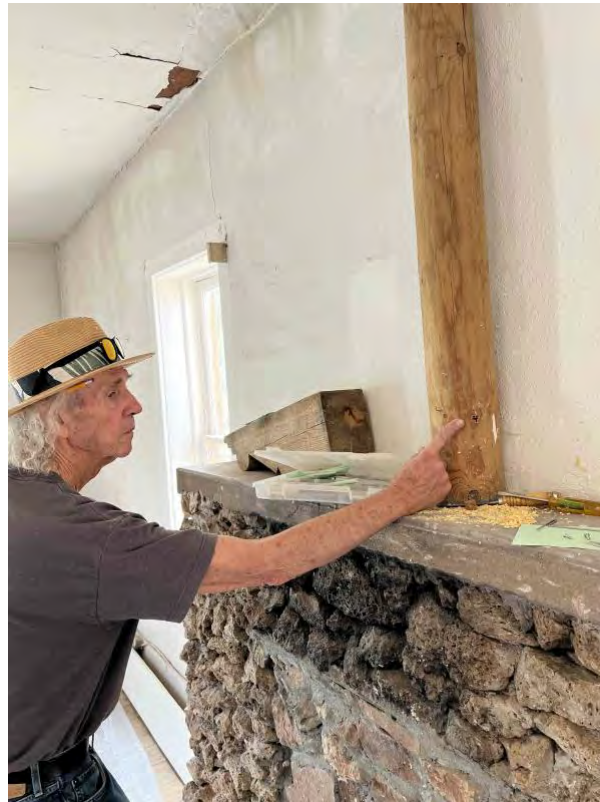
*Fig. 11. Detail of the ponderosa pine post (Adams 4) extending from the fireplace mantle toward the ceiling. The outer (cutting) date of this sample is 1922, contemporary with the ponderosa pine vigas in the northeast addition.*

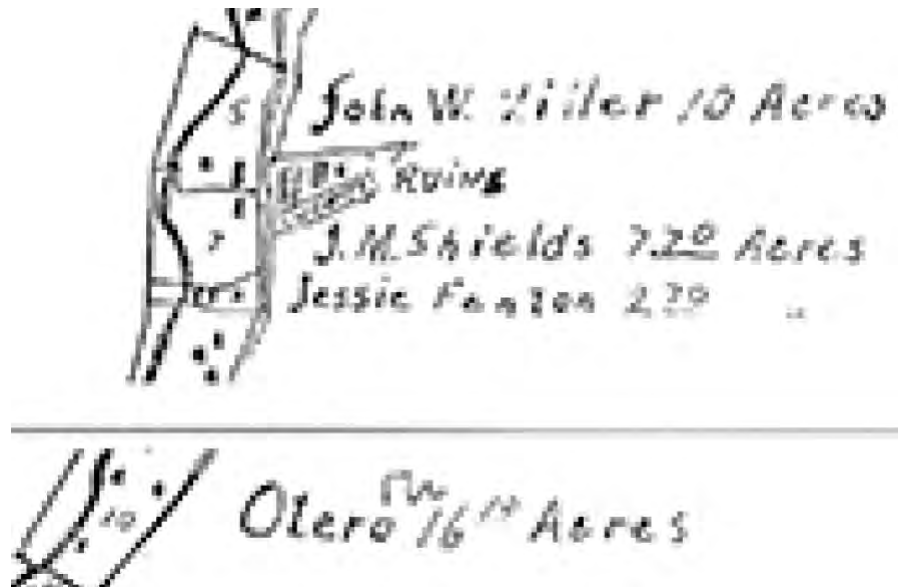
Fig A1. The above is a clip from the hand-drawn 1906 map of land parcels, which was in the John A. Adams papers. The map was titled: "Inholdings Cañon de San Diego Grant, Deed Issues by Jemez Land Co 1906 To (illegible)". Unfortunately, the original map has not been located, and the available copy is low resolution. The full map can be viewed on the Jemez Valley History website at this [link](#). This map was undoubtedly prepared around the time the San Diego land grant was partitioned and sold by court order. It was bought by unscrupulous lawyers and land speculators, who eventually sold the community portion of the land grant to the New Mexico Timber Company at a huge profit. At the time of partition, the private lands along the river were retained (and deeded) to the original land-grant families and others who had previously purchased those parcels along the Jemez River (including the Oteros, Fentons, Shields, and Millers).

John W. Miller and his family had a house just north of the Shields property, and he also owned the land where Mission de San Jose was located, labeled "Ruins" on the map. The land with the mission ruins was later donated (or sold?) to the State of New Mexico. The small parcel on which the Adams house sits is labeled "Jessie Fenton 2.??" [acres, but the decimal numbers are illegible], clearly indicating that the Fenton family owned this property and lived in the house. The Oteros' property, later owned/occupied by the Handmaidens of the Precious Blood nuns, is visible to the south. It is possible that either the Shields or the Oteros sold the small parcel (and house?) to the Fentons, who arrived around 1894.
